3D Laser Scanning

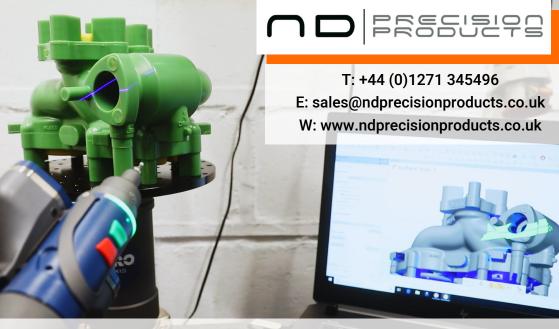
- FARO 3D Laser Scanner with 8-axis
- Comparison reports between the tool model and damaged tooling
- The arm can scan to an accuracy of 46 µm over 2.5m, however, we have conducted tests and have received results of sub 10 µm.
